## **RAILWAY INVESTIGATION REPORT**

**R01E0009**

### **DERAILMENT**

**CANADIAN PACIFIC RAILWAY**

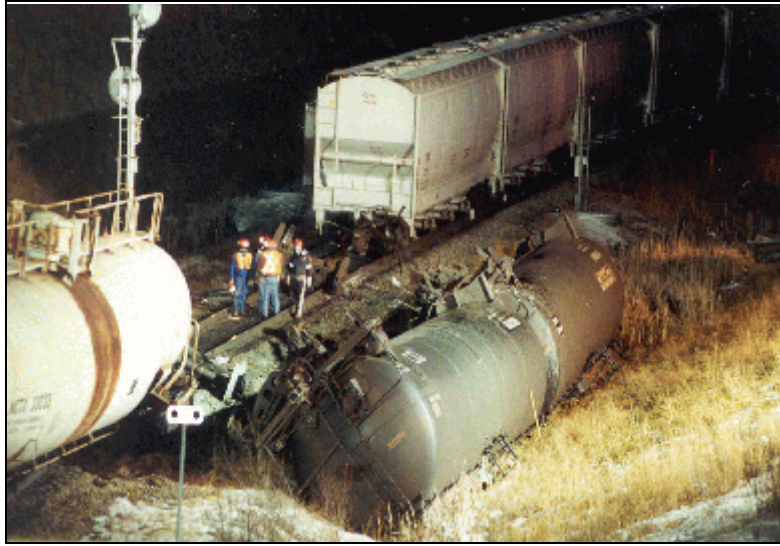
**Figure 2** - Derailed tank cars overturned and resting in ditch.

Three cars remained upright, but the two leading cars (PROX 88421 and PROX 37981) had rolled over falling into the ditch, with the manway nozzles of these cars striking the frozen ground. The entire contents of PROX 88421 were lost due to impact damage (Figure 6). No product was released from the other derailed cars.

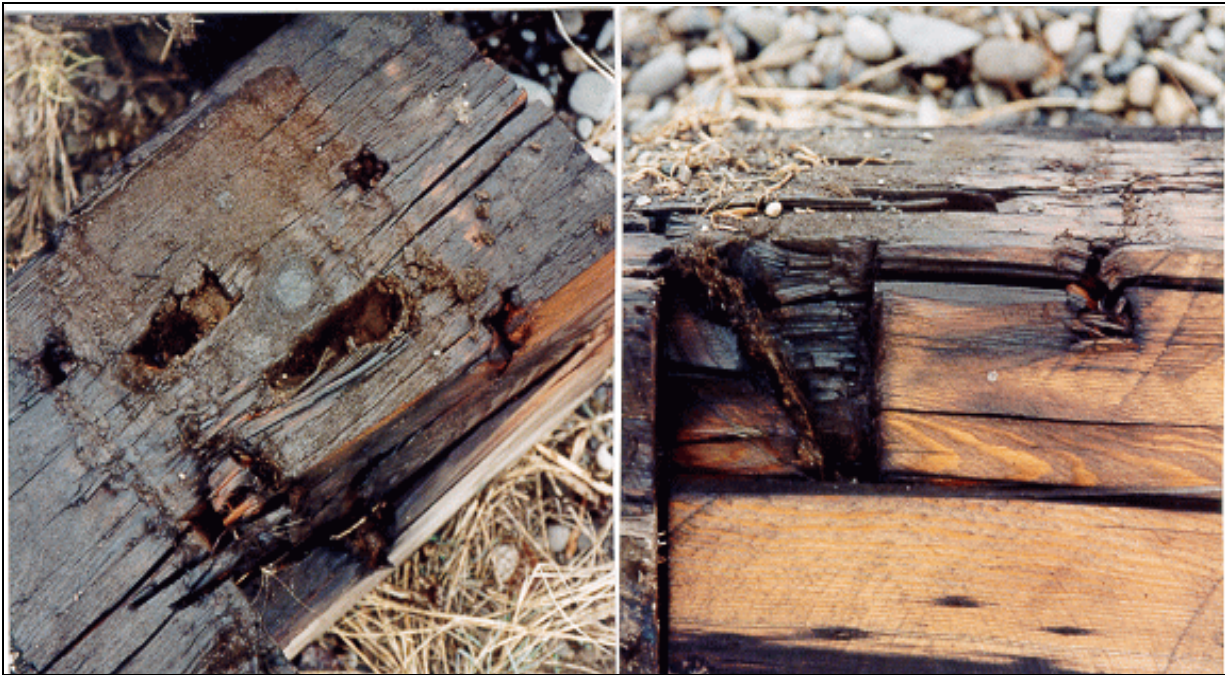
The yard track was built in 1991. The rail at this location was Algoma 115-pound, rolled in 1986 in various lengths. Lengths of rails were joined using splice bars with six track bolts. The subgrade, ballast, and track fasteners were in good condition. A post derailment inspection of the track ties revealed that there was approximately 2½ inches lateral movement in the spike hole and tie plate at the point of derailment. Deformations in the spike holes indicated that the ties were deteriorated and could not hold the proper gauge of the rails. Figure 4 shows the lateral movement at the spike hole.

**Figure 4** - Lateral movement in the spike holes.

The wide gauge condition of the track at the point of derailment was not detected by regular inspection since gauge widening occurred only when the track was subjected to the heavy load of a railcar or an engine. This section of track had not been tested by the track evaluation car. However, if the track had been tested, the likelihood of a wide gauge condition going undetected would have been reduced.

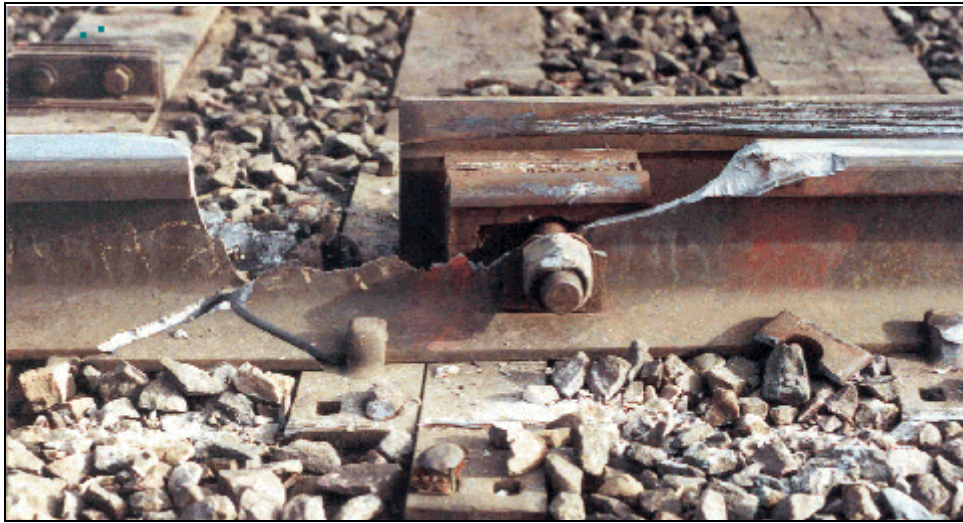
resulted in the complete fracture of the rail. The break was found to have originated from a damaged bolt hole where a guard rail was connected to the running rail (Figure 5).

**Figure 5** - The broken rail at the point of divergence.

The Engineering Branch analyses revealed that the primary mode of failure was overstress originating from pre-cracks located on either side of a bolt hole. The pre-cracks were heavily oxidized, indicating long-term growth. One pre-crack measured 26 mm in length and had penetrated through the 17 mm thick web to the other side. The other pre-crack measured 18 mm in length and was 9 mm through the thickness of the web. Both pre-cracks coincided with significant prior damage to the bolt hole from rubbing by a loose bolt. The rubbing had resulted in deformation of the bore of the hole, and extrusion of the metal forming a lip on the outside surface.

The bolt hole in the web of the rail had significant long term damage caused by the bolt rubbing against the hole, indicating that, at some point in time, the bolt had not been adequately tightened. As the nut of the bolt on the field side of the rail, and a spacer block on the gauge side, completely concealed the bolt hole, visual turnout inspections did not detect the damage. Monthly visual turnout inspections and detailed semi-annual turnout

The damage to the bolt holes caused two pre-cracks to form in the rail. Their location was such that they too would not have been detected during the monthly turnout inspections. Both pre-cracks were large enough to reduce the strength of the rail to such an extent that the lateral stresses caused by the derailed car hitting the frog were great enough to fracture the rail.

4. Canadian Pacific advises that, in addition to testing main track sidings at least twice a year, they are now testing all sidings, including the No. 1 yard track in Red Deer.

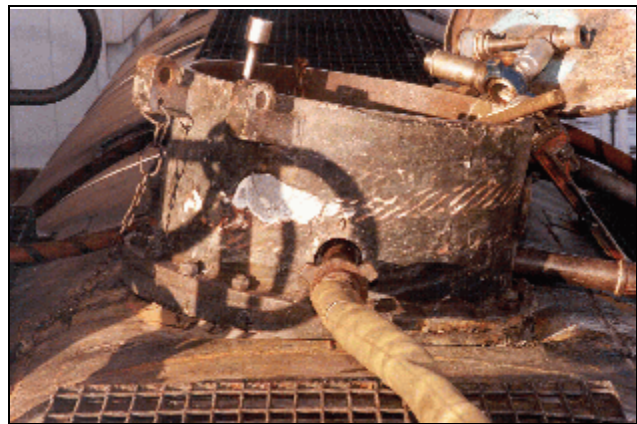
TSB Engineering Branch Report LP009/2001 indicates that the manway nozzle of tank car PROX 88421 was subjected to a significant overstress during the derailment and falling over which led to a brittle fracture opening of some 5.125 square inches in the heat-affected zone of the weld between the manway nozzle and the shell of the tank (Figure 7). The car also sustained a shear fracture of the metal at the sill area which initiated from a small pre-crack located in the toe of the sill-to-pad weld on the outside of the sill. The ammonia was released into the atmosphere gradually, which prevented the formation of a large cloud of gas at the time of the occurrence. Liquid ammonia was still slowly leaking from the car 24 hours after the occurrence.

**Figure 6** - Damage to dome area of PROX 88421.

1. Within the first week after the derailment, the Procor company undertook mapping of the distorted area of the car PROX 88421 as well as the other derailed and overturned car, PROX 37981. Furthermore, Procor acquired a non-linear finite element analysis capability. The results of the distortion mapping were analyzed by using this newly acquired capability to learn the distribution of the stresses to which the cars were exposed. In addition, designs of the manway area of other tank cars are being analyzed in similar fashion. This work may ultimately lead to improvements in car design applicable to the whole North American fleet. In addition, Procor performed material testing over and above that performed by the Transportation Safety Board of Canada, in order to confirm the material properties of the tank and welds.

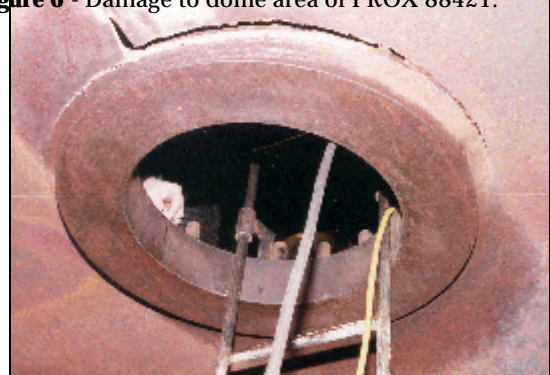
**Figure 7** - Interior photo of the failed weld area around the manway.

shallow pre-cracks, ranging from 11 mm to 45 mm in length, on the inner surface of the plate steel, which probably formed as a result of thermal stresses induced at the time of construction. There was no evidence of pre-impact growth and the surfaces of these cracks were covered with thick oxide layers (rust), indicating that they had been present and lain dormant for some time. A review of the running history and maintenance of this car (PROX 88421) proved uneventful as no significant repair history was indicated. The report also indicated that the structural failure was a brittle fracture due to the impact forces of the loaded tank car nozzle contracting the frozen earth. The kinetic analysis determined that the impact on the tank car nozzle was several times greater than that required to exceed the design strength of the car structure.

Tank car PROX 88421 had three shallow pre-cracks on the inner surface of the manway plate. It is likely that they were formed as a result of thermal stresses induced by the welding of the manway nozzle to the shell of the tank at the time of construction. Although cracks of this nature would not normally be expected to weaken the load-bearing ability of the plate, they do provide an imperfection in the surface metal and can act as points of stress concentration and provide origins for brittle failure. Therefore, while these pre-cracks may exist for many years without compromising the integrity of the plate under normal operating conditions, a brittle failure may occur when exposed to abnormally high stress levels at low ambient temperatures. The stresses caused by the impact to the manway nozzle exceeded the structural design capabilities of the tank, resulting in a brittle fracture and the gradual release of ammonia. The brittle fracture was confined to the heat-affected zone of the weld between the nozzle and the tank shell.
